Content: **Test Report**

Project: B + BTEC Pendulum impact test glass balustrade

Project number: VT 21-1125

Contract: Impact tests with twin tires according to DIN 18008-4 on a balustrade system

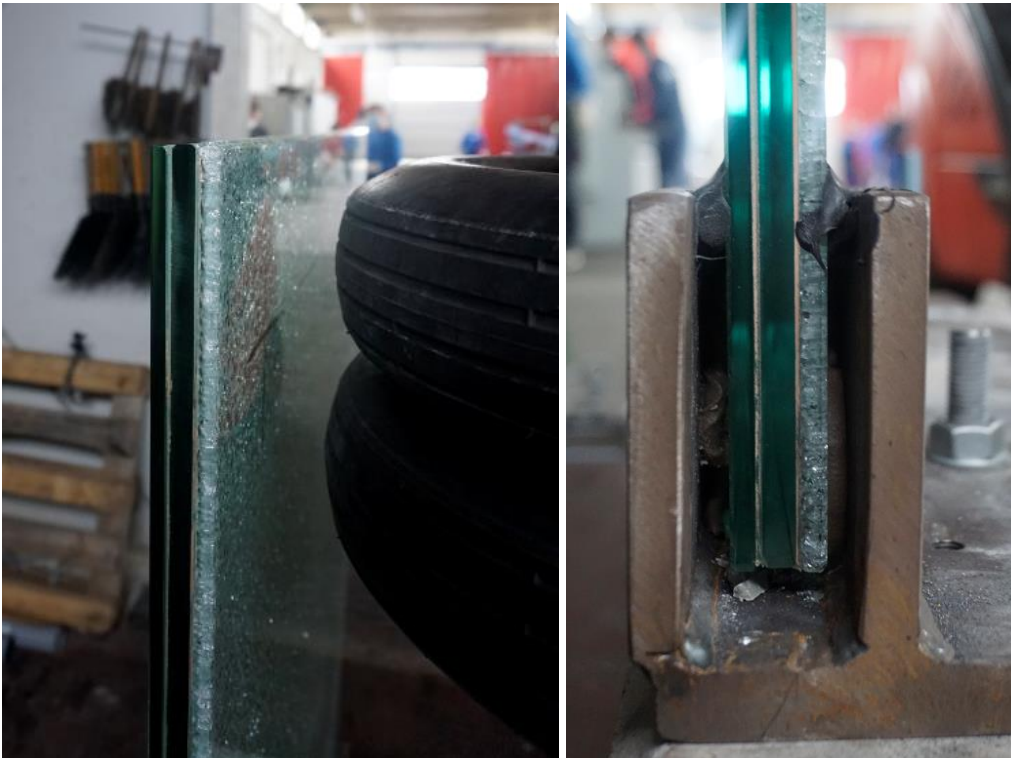
| Sample | Fall height Δh [mm] | Impact Point | Result |
|---|--|---|--|
| | | 4 | <ul style="list-style-type: none"> Breakage of the inner ESG (see Image 10) No visible damage to the substructure |
| | 100 | 4 | <ul style="list-style-type: none"> No other damages to the glazing No visible damage to the substructure |

Image 10 Breakage of the inner ESG at impact point 4 (PK1)

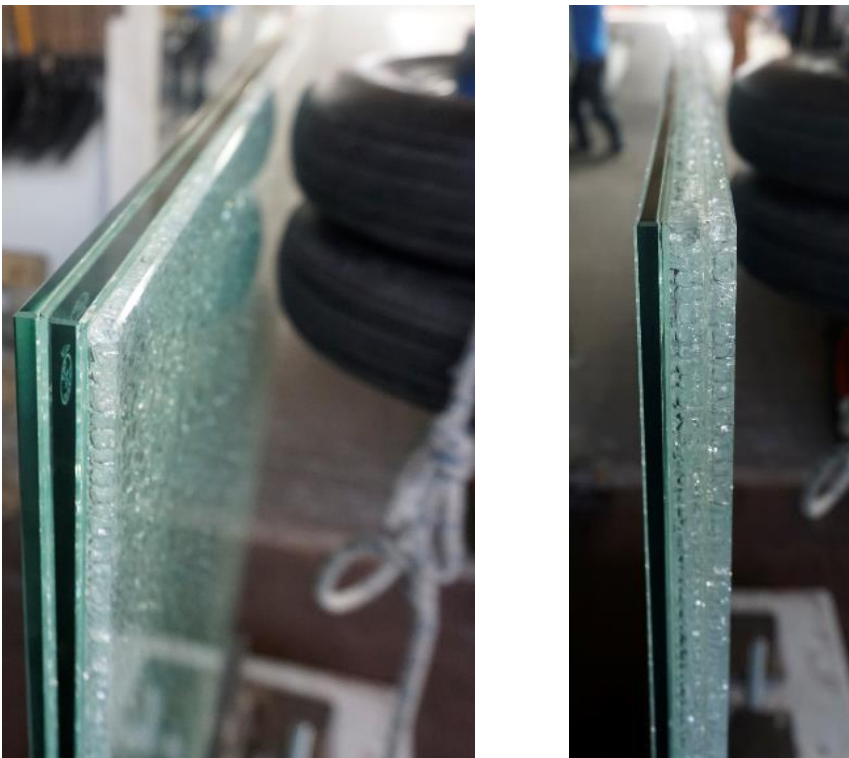
| Sample | Fall height Δh [mm] | Impact Point | Result |
|---|--|---|--|
| | | 3 | <ul style="list-style-type: none"> Breakage of the inner ESG pane (see Image 11) No visible damage to the substructure |
| | Striking of the middle ESG pane and additional test with reduced drop height | | |
| | 450 | 3 | <ul style="list-style-type: none"> No other visible damage to the glazing No visible damage to the substructure |

Image 11 Breakage of the inner ESG at impact point 3 (PK2) / breaking of the 10 mm ESG before pendulum with 450 mm fall height (right)
